Evaluation of Paul Bergsoe and
Son Secondary Lead Smelter

Radian Corp.
Austin, TX

Industrial Environmental Research
Lab.-Cincinnati, OH

EPA-600/2-80-022
January, 1980

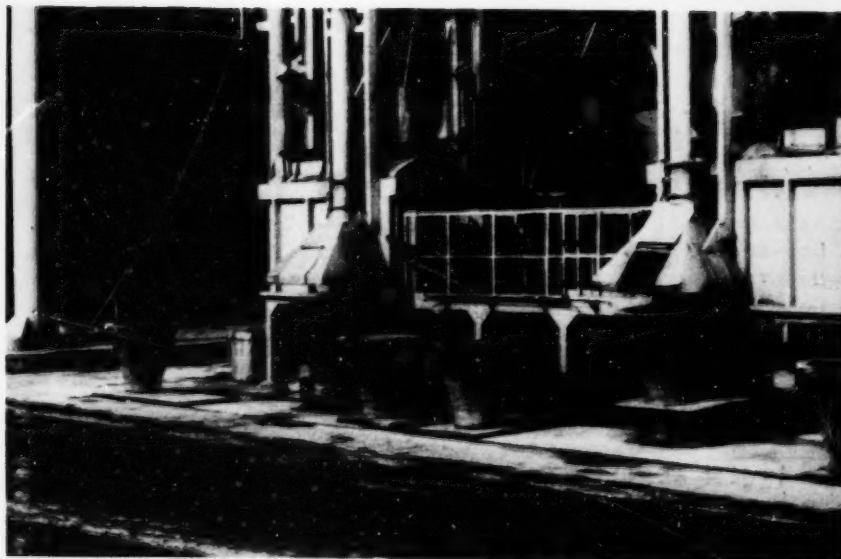
PLATE 4. View of agglomeration furnace.

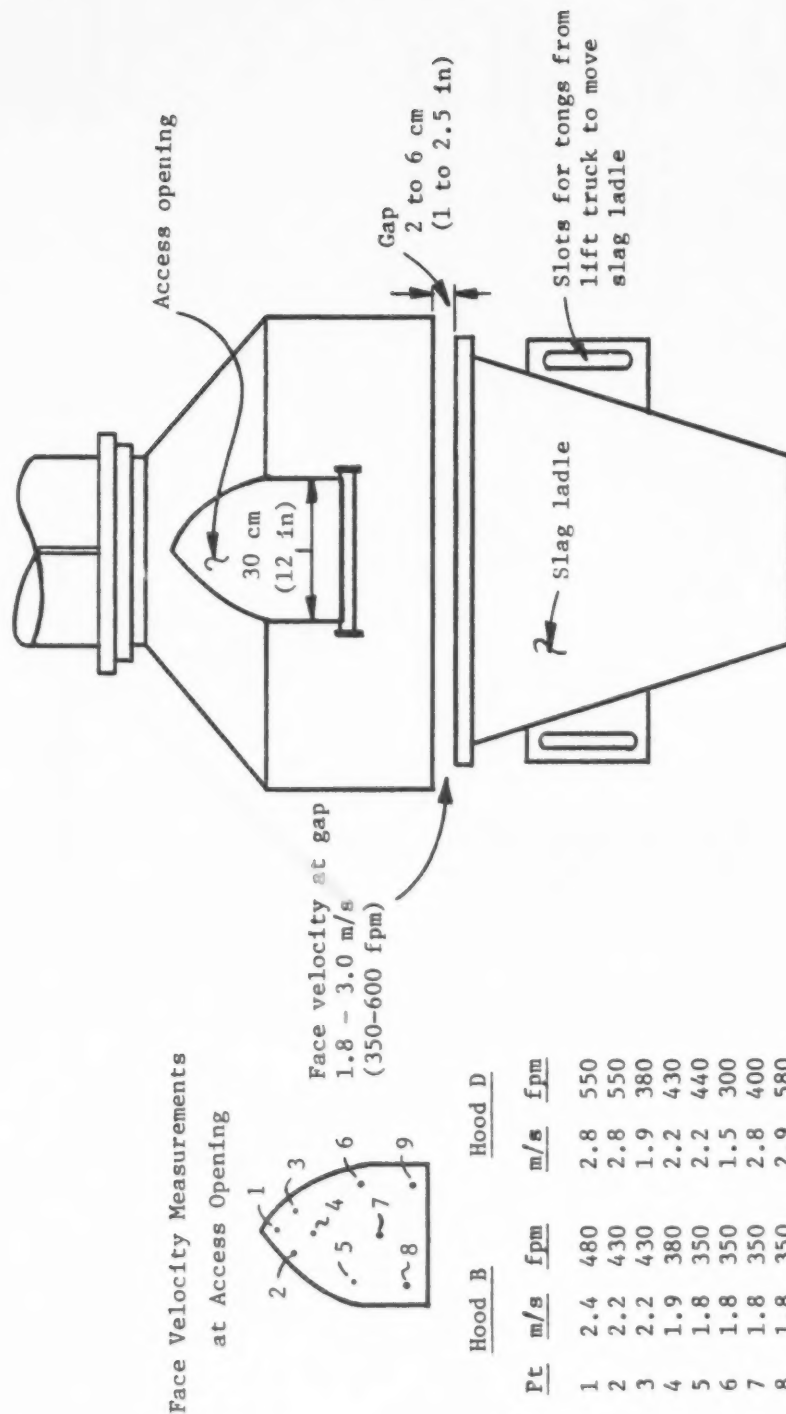
Figure 19. Front elevation - slag tapping ladle (Hoods A,B,C,D).

Figure 19 illustrates the relationship of the slag hoods to the slag ladles. Air velocities measured at the access opening and along the gap between the hood and ladle are indicated. As can be seen from the data, these hoods afford vigorous face velocities.

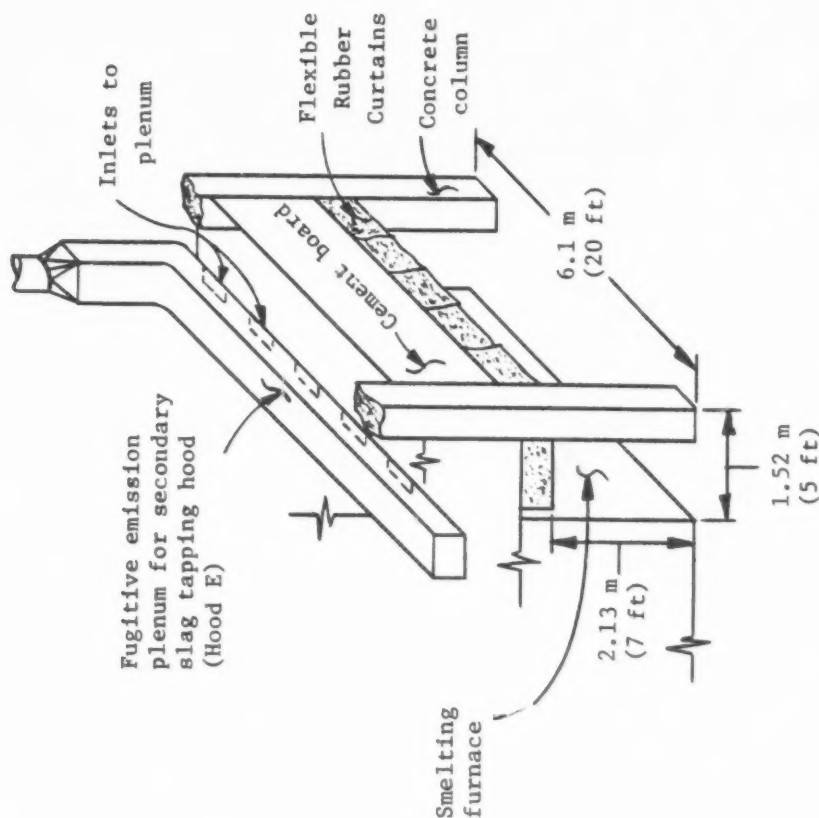
Figure 20. Secondary slag tapping hoods (Hoods E and F).

- Air velocities near tuyeres and flexible rubber curtains were less than 0.13 m/s (25 fpm)
- Smoke generated inside the hood was observed to flow upward toward the exhaust plenum inlets
- Smoke generated near the flexible rubber curtains indicated low order turbulence on back side of curtains

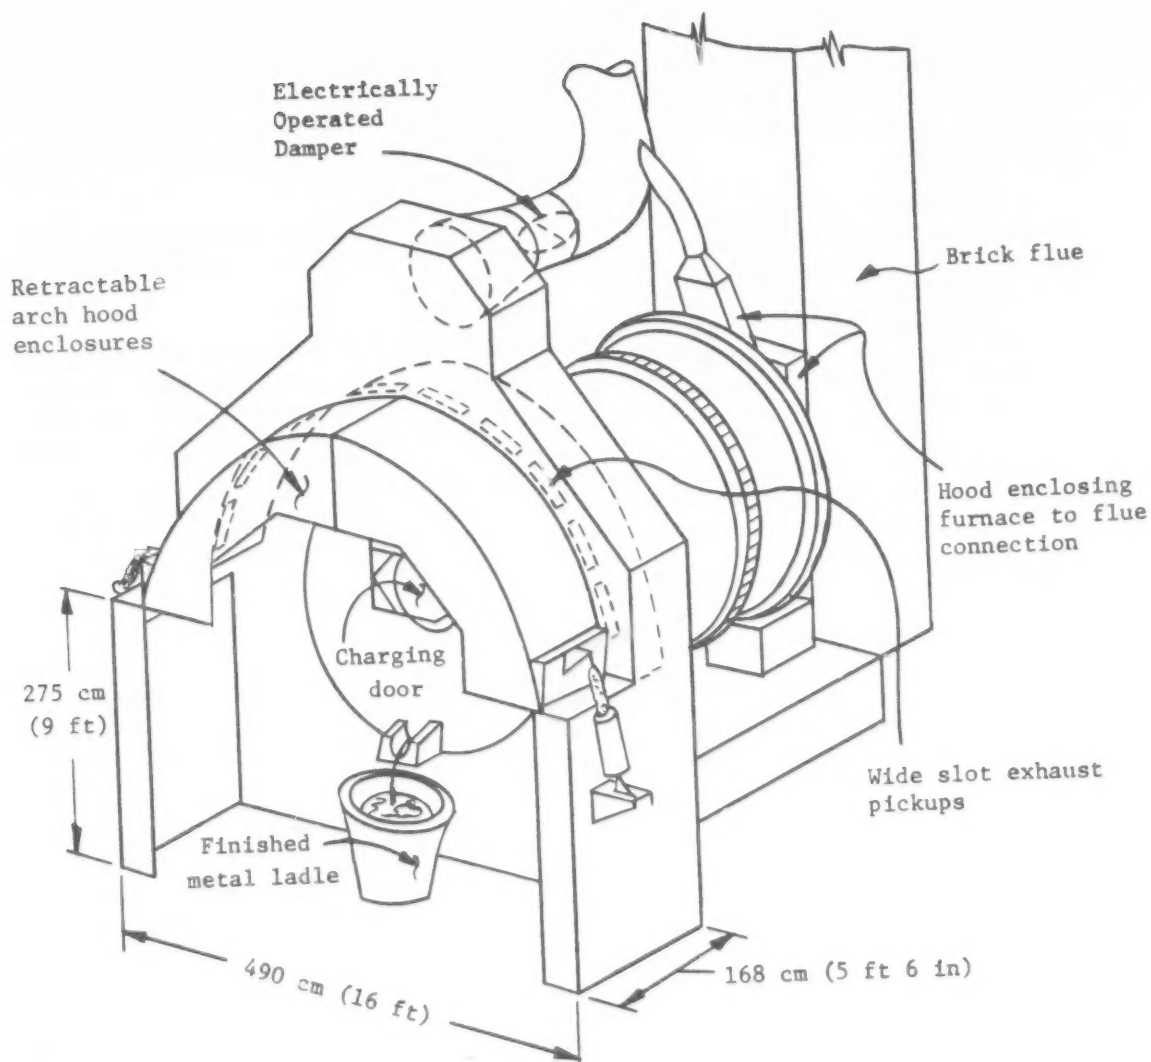
Charge materials for the rotary furnace are placed in specially designed charge containers which rest on a low platform behind the roll-up door between the furnace operating and charge preparation section of the building. Figure 23 shows the location of this charge container resting platform. Figure 24 shows a close up of the charge resting platform and a detail of an individual charge container.

Figure 24. Close-up of charge container resting deck, roll-up door, and detail of charge container.

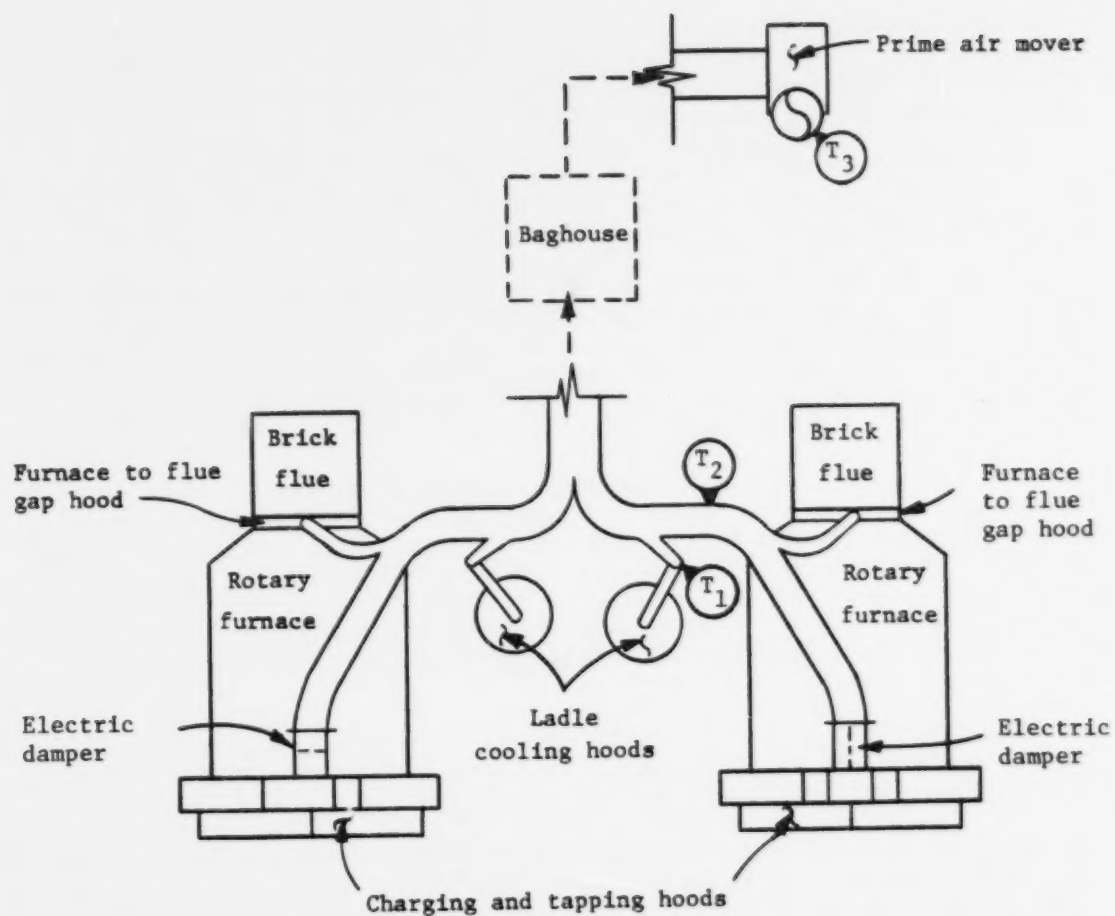
Observations--The rotary furnace exhaust ventilation system was found to be in good repair. No serious dents or malformations in ductwork were found. The system is constructed of heavy gauge steel.

During the day this system was evaluated, problems were encountered with the baghouse bag cleaning mechanism. A portion of the baghouse jammed in the cleaning cycle mode which resulted in significantly reduced draft to the furnaces while repairs were made. Emissions were observed to escape from the arched hoods during this period. These emissions visibly contaminated the rotary furnace operating area for over an hour.

The day prior to process evaluation, the electric damper behind the arched hood on one of the rotary furnaces broken down and required repair. During the repair period significant quantities of air contamination escaped into the workplace. Also during this workday a major spill of finished metal occurred when the receiving ladle was accidentally overfilled. The metal spilled out onto a wetted floor which caused generation of copious quantities of steam but no serious splashes or projection of hot metal occurred.

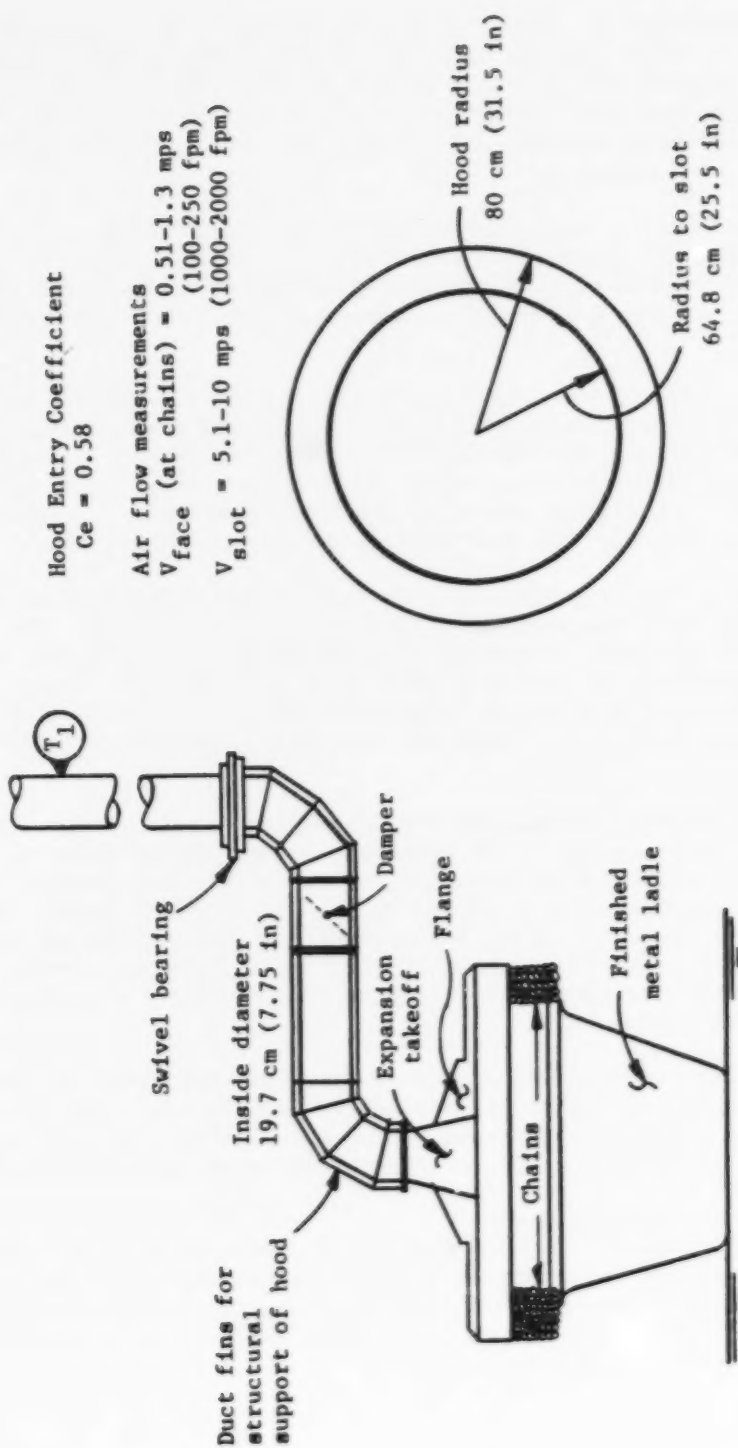
Engineering Measurements--Figure 27 presents a sketch of one finished metal ladle cooling hood used in the rotary furnace operating area. Hood dimensional and performance data are contained in Figure 27 and Table 26. As can be seen from the figure, this is a slotted hood which spreads the capture zone around the perimeter of the ladle.

Figure 27. Finished metal ladle cooling hood.
